LITTLE CANNON AT OXFORD MILL

Little Cannon River near Oxford Mill (LCO-5)

LITTLE CANNON RIVER (LCO-5)

LITTLE CANNON RIVER AT OXFORD MILL

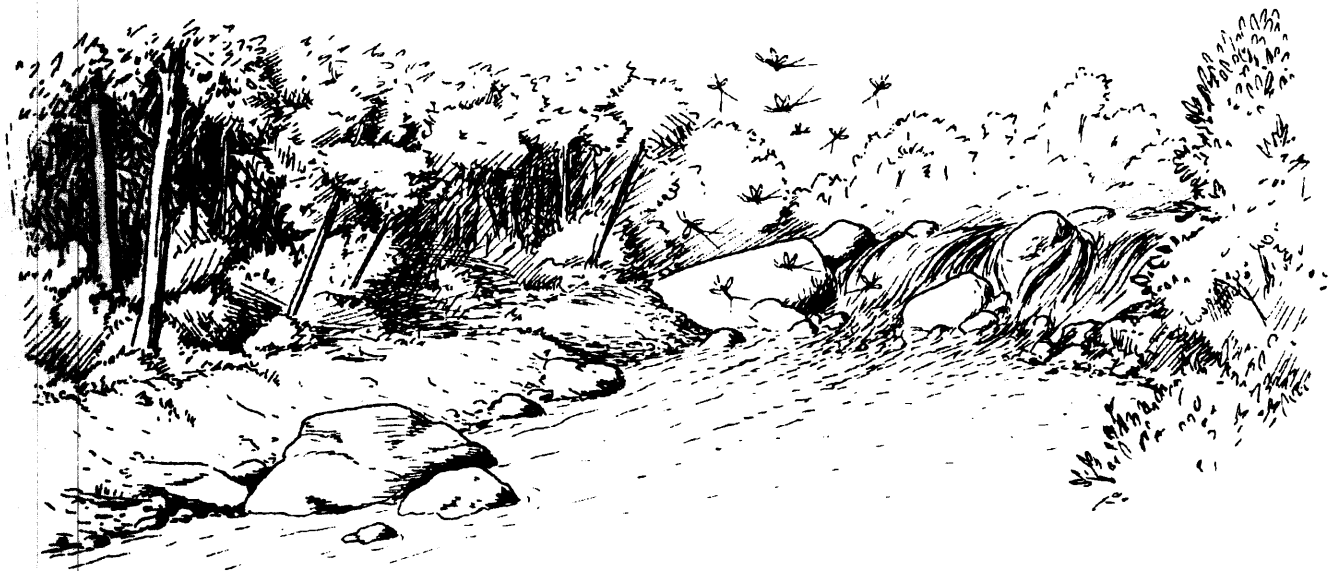
Type: Midsize stream 4 miles upstream from mouth

Riparian: Residential, Old field

Instream: Cobble, sand, gravel, and fine sand forming bars in slow current
