LOWER CANNON NEAR RED WING

Lower Cannon River near Highway 61 (LCH-1)

LOWER CANNON RIVER (LCH-1)

U. S. Highway 61 near Red Wing

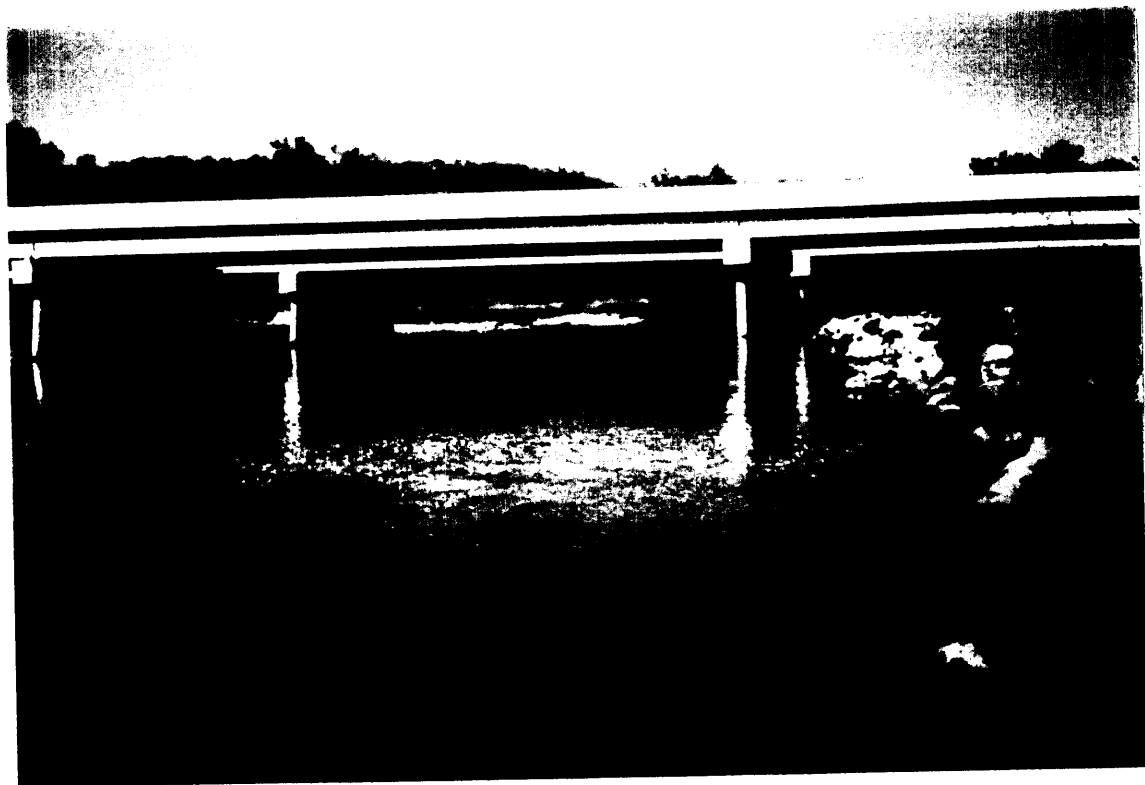
Riparian: Forest, Old field, Newly developed flood plain with riprap

Instream: Sand and silt with riprap banks

Comments New riprap on both shorelines and grasses planted on floodplain.
