CRANE CREEK

Crane Creek (CRC-25)

SITE **CRC-25** Location CRANE CREEK 3 MILES WEST OF OWATONNA AT HIGHWAY 14

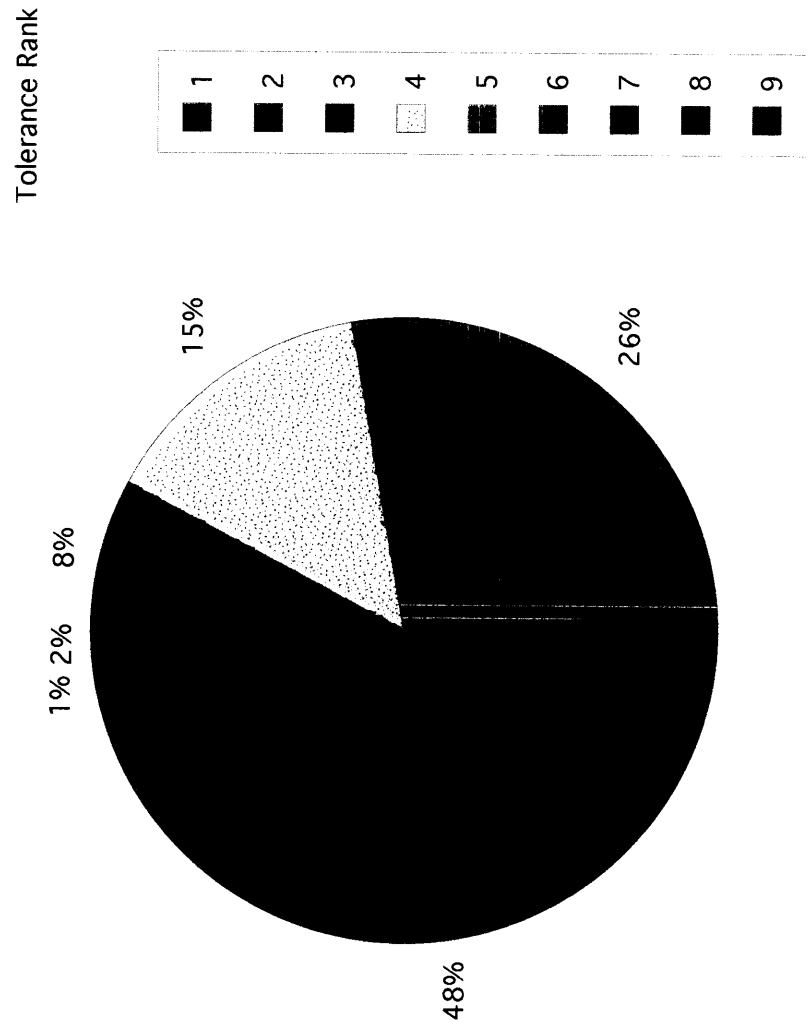
Percent Macroinvertebrates by Tolerance Rank

Site	NUMBER OF INSECTS BY TOLERANCE RATING										PERCENT IN TOLERANCE RANK								
	1	2	3	4	5	6	7	8	9+	TOTAL	1	2	3	4	5	6	7	8	9
CRC 1994	0	0	116	242	350	302	1	1	1	1013	0%	0%	11%	24%	35%	30%	0%	0%	0%
CRC 1995	0	2	156	104	363	878	20	36	12	1571	0%	0%	10%	7%	23%	56%	1%	2%	1%
CRC 1996	0	0	82	303	468	951	3	73	7	1887	0%	0%	4%	16%	25%	50%	0%	4%	0%
CRC TOTAL	0	2	354	649	1181	2131	24	110	20	4471	0%	0%	8%	15%	26%	48%	1%	2%	0%

The number of different taxa found at the site was quite surprising considering Crane Creek appears to be just a drainage ditch. Everything from leeches to stoneflies were found at the site. The diversity of the taxa present increased in each year of the study. Very large numbers of beetles, caddisflies, mayflies, and midges were collected in 1996. In 1994, when water levels were high a very large population of amphipods was found with the caddisflies and mayflies. In 1995 caddisflies and midges dominated the sample. The ICI and Diversity Indices ranked slight in impact while Richness and Equitability ranked moderate. The tolerance rank ranged from 2 to 11, a very broad range. Almost 90% of the insects collected were in the 4 - 6 range for tolerance rank with 48% in rank 6, 26% in rank 5, and 15% in rank 4.
