Date: January 11, 2008

To: Volney Lake Association

Subject: Environmental Assessment Overflight of Volney Lake

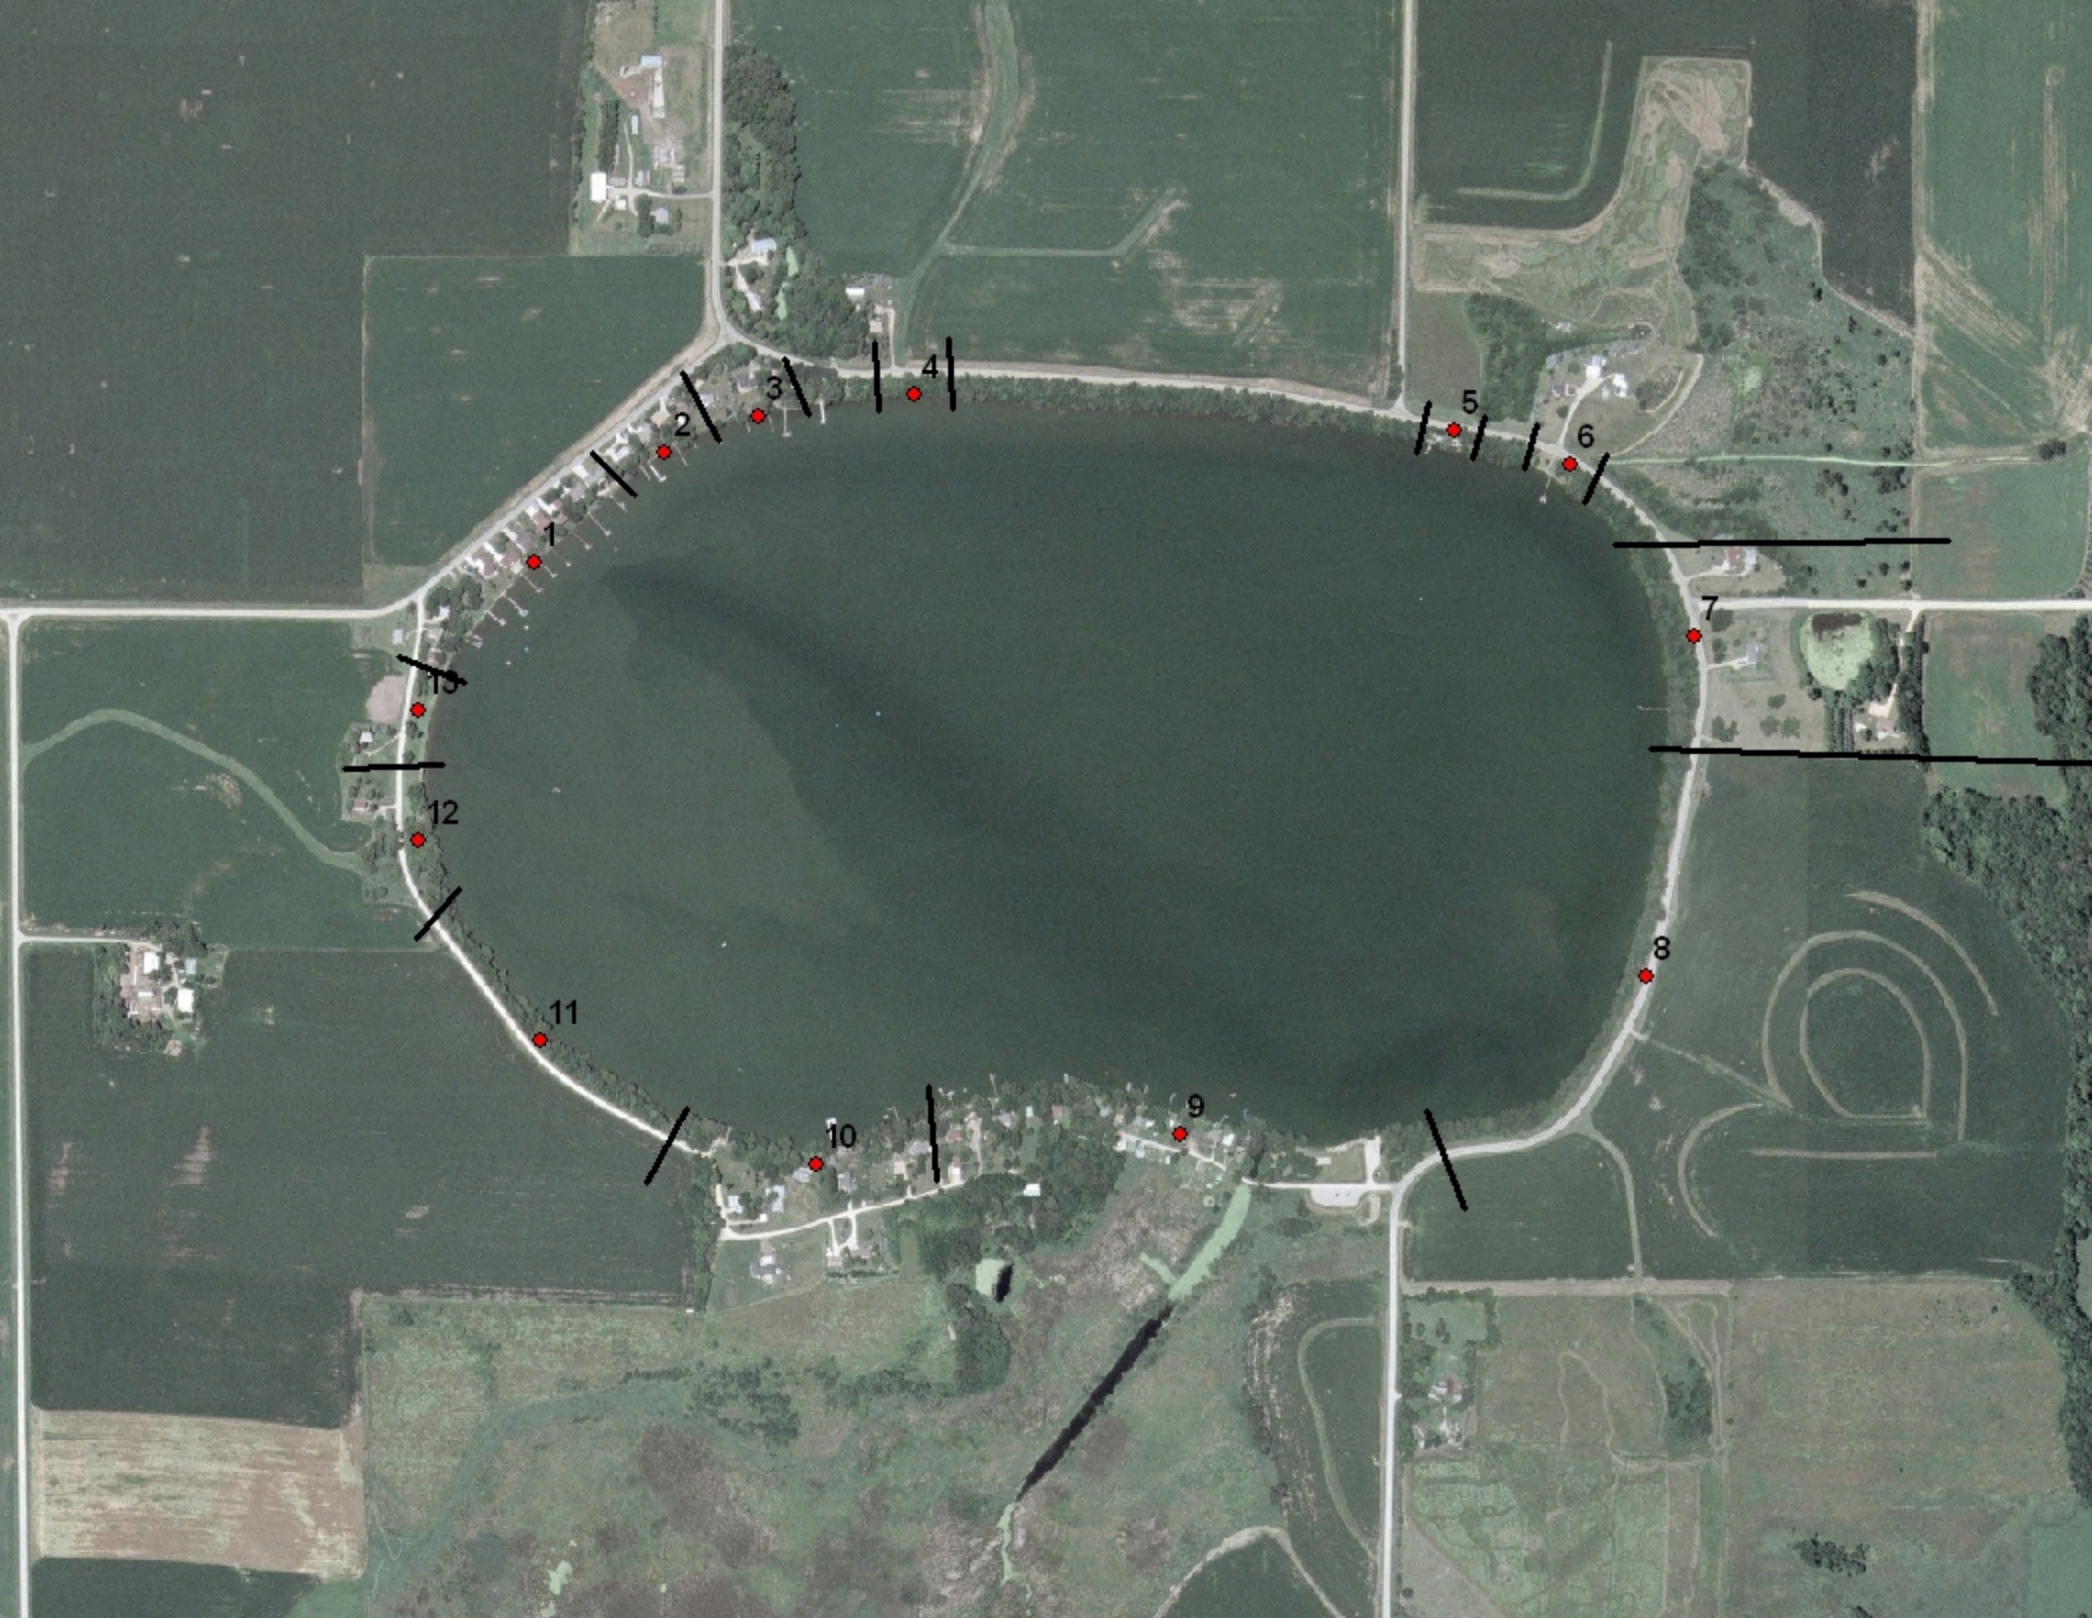
- 1
- 2
- 3
- 4
- 5
- 6
- 7
- 8
- 9
- 10
- 11
- 12
- 13

Image sites are marked on the topographical maps located in the front of the report. These numbers correlate with image site numbers.
