Lake Volney Excess Nutrient TMDL Implementation Plan

June 2011

Prepared by
Water Resources Center
Minnesota State University, Mankato

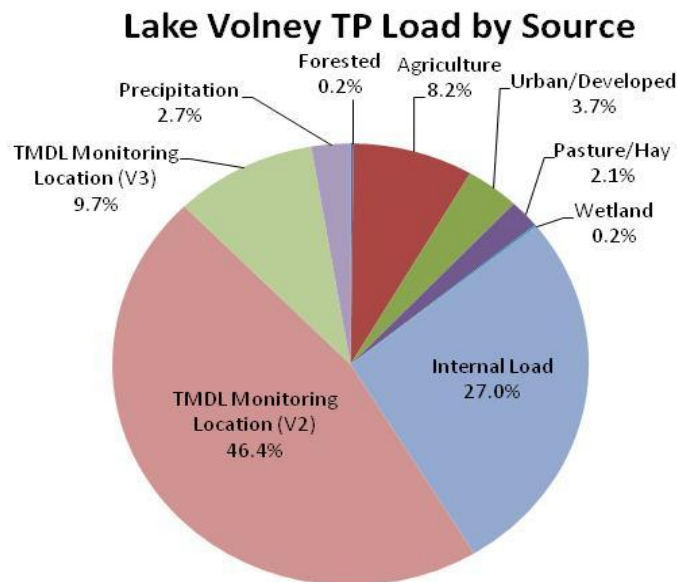
All data observed from monitored and non-monitored surface water inflow sites, land use values, watershed size, lake morphometry, precipitation/evaporation rates, and observed in-lake water quality conditions were used to develop the BATHTUB model. Results from this model were used to estimate the total current daily load as well as the total maximum daily load that would allow Lake Volney to meet standards set forth for the NCHF ecoregion. Loading of nutrients from external sources was not great enough to account for the observed water quality conditions on Lake Volney. Therefore, the remediation of Lake Volney will entail a reduction in nutrient sources from both internal and external sources. The proceeding chart highlights the phosphorus sources to Lake Volney.

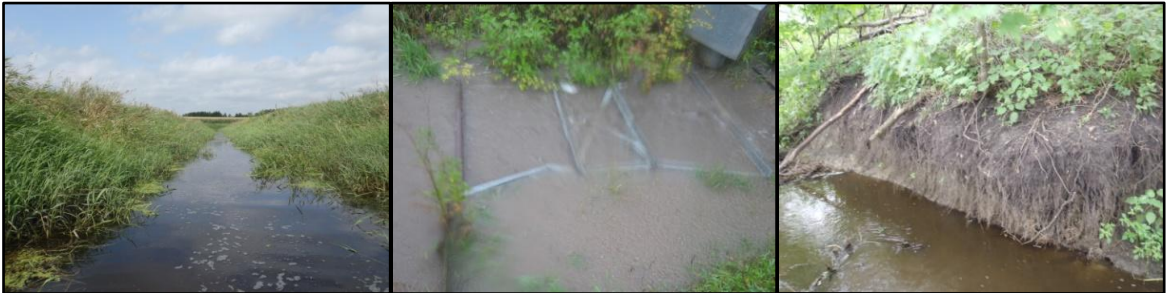
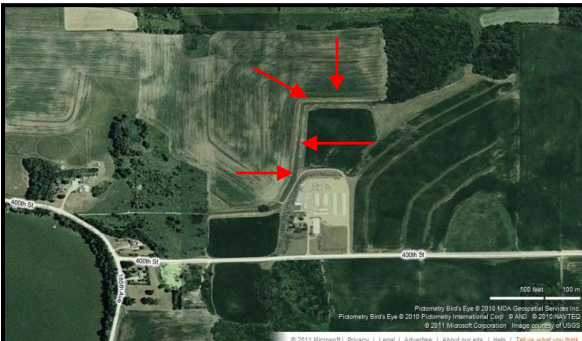
Proposed Location

Current Conditions: The ditch at monitoring location V2 has the potential to contribute a large nutrient load following storm events. The wetland upstream of this location is overburdened by nutrient loading and subsequently releases a large nutrient load to the ditch and eventually to Lake Volney. A two staged ditch would provide a great opportunity to filter nutrients prior to reaching Lake Volney especially during storm events.

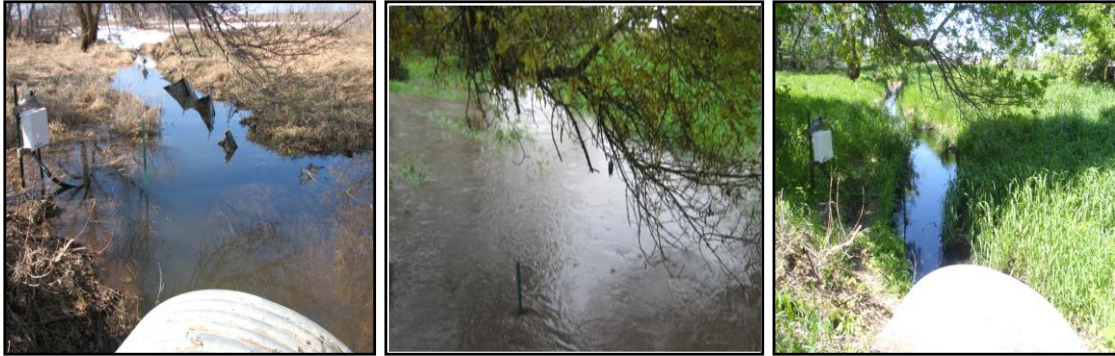
Proposed Location

Current Conditions: The ditch at monitoring location V3 periodically rose out of its banks following snowmelt in the spring and after storm events throughout the summer. The surrounding floodplain was saturated with water during these events. Sediments

and nutrients from the stream bank were easily washed into Lake Volney during these high flow events.

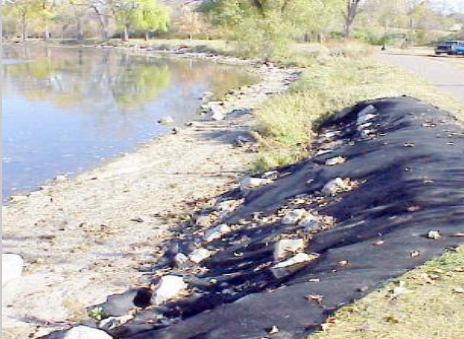
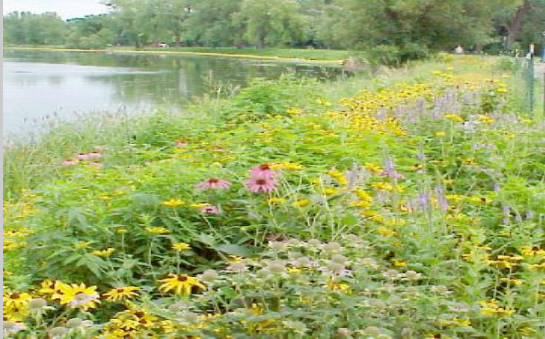
Degraded Shoreline	Restored Shoreline

<ul style="list-style-type: none"> • Does not capture runoff from impervious surfaces. • No value to wildlife. • Vulnerable to erosion. • No aesthetic value • <u>Decreased Property Value!</u> 	<ul style="list-style-type: none"> • Captures a large portion of the runoff from impervious surfaces. • Provides habitat for frogs, fish, butterflies and other wildlife. • Can reduce erosion if properly installed. • Great aesthetic value. • <u>Increased Property Value!</u>

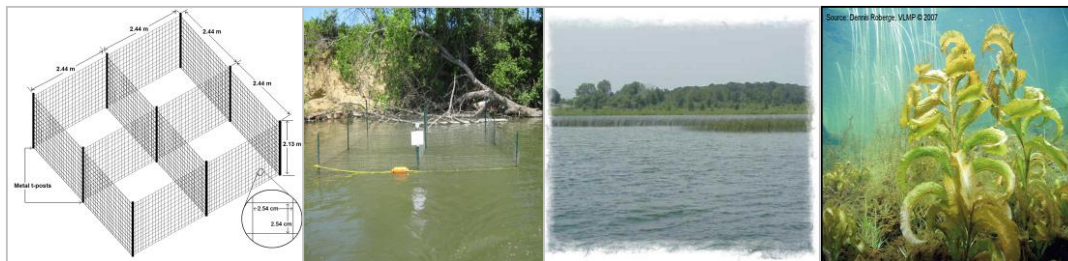
The native plant community in Lake Volney is extremely limited. Curly-leaf pondweed was the only submergent macrophyte found during the May 2009 survey, while a total of three species of macrophytes (curly-leaf pondweed, narrow-leaf cattails, and sago pondweed) were found during the August 2009 survey. In the absence of native submergent macrophytes, the algal community is allowed to grow relatively uninhibited.
